DEPARTMENT OF TRANSPORTATION

Quality Assurance and Source Inspection

Contract #: 04-0120F4Cty: SF/ALA Rte: 80 PM: 13.2/13.9File #: 1.28**WELDING INSPECTION REPORT****Resident Engineer:** Casey, William**Address:** 333 Burma Road**City:** Oakland, CA 94607**Report No:** WIR-027204**Date Inspected:** 17-Feb-2012**Project Name:** SAS Superstructure**OSM Arrival Time:** 700**Prime Contractor:** American Bridge/Fluor Enterprises, a JV**OSM Departure Time:** 1530**Contractor:** American Bridge/Fluor Enterprises, a JV**Location:** Jobsite**CWI Name:** As noted below**CWI Present:** Yes No**Inspected CWI report:** Yes No N/A**Rod Oven in Use:** Yes No N/A**Electrode to specification:** Yes No N/A**Weld Procedures Followed:** Yes No N/A**Qualified Welders:** Yes No N/A**Verified Joint Fit-up:** Yes No N/A**Approved Drawings:** Yes No N/A**Approved WPS:** Yes No N/A**Delayed / Cancelled:** Yes No N/A**Bridge No:** 34-0006**Component:** SAS OBG**Summary of Items Observed:**

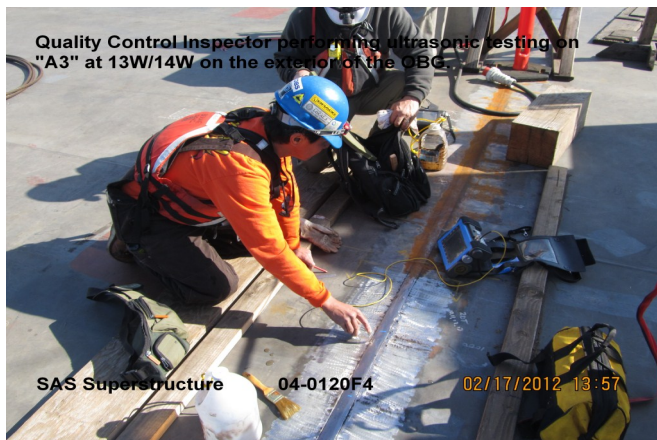
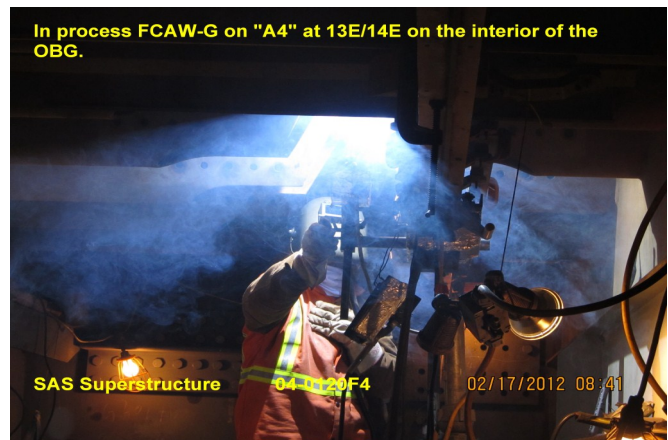
This QA Inspector randomly observed ABF welding operator James Zhen (ID 6001) performing the Flux Core Arc Welding with gas (FCAW-G) process utilizing a "Bug-O" motorized rail system with a magnetic base attached in the (4G) overhead position on the underside of deck plate "A4", at 13E/14E of the OBG. This QA Inspector observed QC Inspector Fred Von Hoff monitoring the welding to ensure the welding parameters were in compliance pertaining to ABF-WPS-D15-3110-4. The parameters were recorded as (A=255/V=23.6/TS=190/HI=1.90). This QA inspector made subsequent observations throughout the shift to monitor quality and noted that the work was completed on this date and appeared to be in general conformance to the contract requirements. This Joint is a Seismic Performance Critical Member (SPCM).

This QA Inspector randomly observed ABF Quality Control Inspector Mr. Bernie Docena performing Ultrasonic Testing (UT) inspection on "A3" of 13W/14W on the exterior of the OBG. This QA Inspector observed that Mr. Docena detected two (2) rejectable indications located at y+3370mm; 40mm's in length and 10mm's deep, y+4080mm's; 50mm's in length and 14mm's deep. The deck at this location is 20mm thick and is a Seismic

This QA Inspector performed a Magnetic Particle (MT) Inspection on longitudinal stiffeners #4, 5 and 6 at 12E/13E on the interior of the OBG. This QA Inspector performed the yoke method in conformance with ASTM E 709 and the standard of acceptance with D1.5 section 6.26. This QA Inspector noted that no rejectable indications were found at the time of testing. This QA Inspector generated a TL-6028 MT report on this date. The completed work at this location appeared to be in general conformance with the contract specifications.
